1. Purpose and scope of this memorandum

This memorandum summarizes a site survey performed July 5, 2018 to evaluate the condition of ADA mandated access at Tubb's Meadow Preserve in Pembroke Massachusetts. After a description of the site and site uses, recommended improvements are provided in Section 7, beginning on page 2.

Tubb's Meadow Preserve Access at Monroe Street and Mill Street

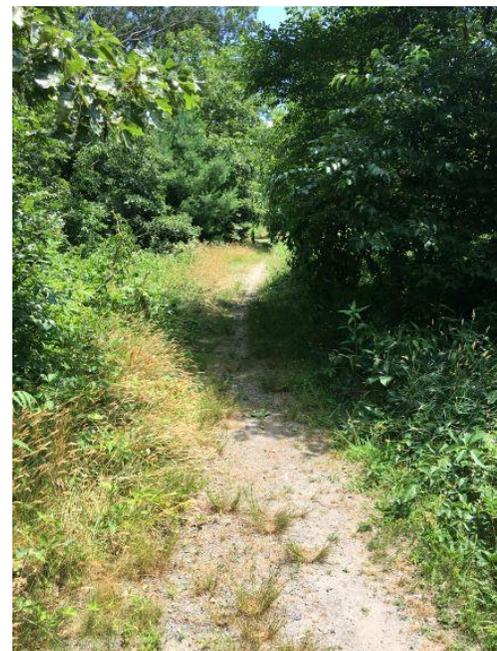
feet and has space for approximately 6 cars. No marked parking stalls or signage is present at either access; no handicapped spaces are indicated. The dirt road surface is compacted and its width is adequate for access.
